This report summarizes the details and results of various studies which have been performed as part of the Connecticut Department of Transportation's (CTDOT) planning process for the Reconstruction of Interstate 84/CT Route 8 Interchange Project (the I-84 Mixmaster Reconstruction Project, the Project). The Project has been initiated by the CTDOT to enhance safety, improve structural conditions, and correct operational and geometric deficiencies of the Interstate 84 (I-84) and Route 8 "Mixmaster" interchange and larger transportation network in the Waterbury area.

The content of this *Analysis, Needs, and Deficiencies Report* is primarily intended to guide the development of conceptual Project improvements. The future "no build" scenario will be used as a benchmark condition for comparison and evaluation of improvement concepts. This report purposefully does not discuss or consider Project improvement concepts.

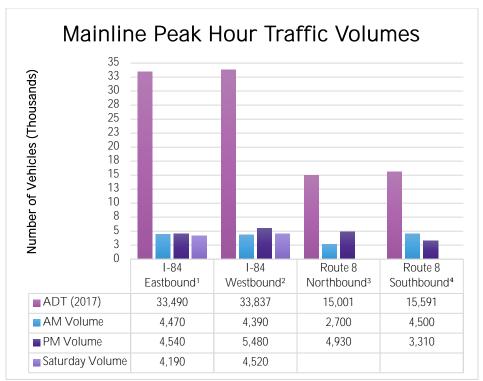
Figure 2-1 Mainline Peak Hour Traffic Volumes

Figure 2-1 shows the calibrated (or balanced) traffic volumes for each corridor during the selected peak hours along and their corresponding 2017 average daily traffic (ADT). Additional detailed volume maps can be found in **Appendix 2.2** (refer to **Highway Volume Maps**).

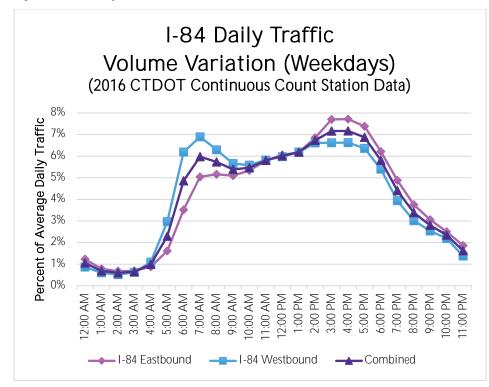
Figure 2-2 I-84 Daily Traffic Volume Variation

Figure 2-2 through Figure 2-7 show the daily and weekly traffic volume variation for I-84 and Route 8.

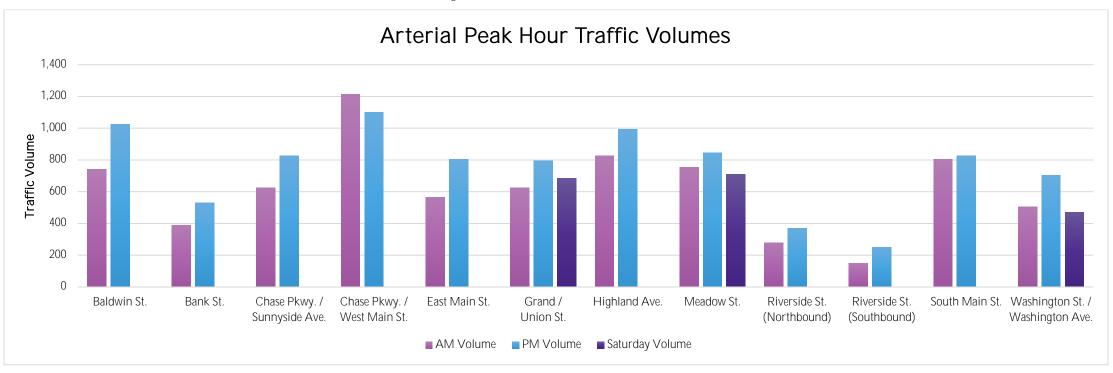
Figure 2-8 Arterial Peak Hour Traffic Volumes

Arterial and intersection traffic volume data was obtained in 2017 for 65 intersections (see Figure 2-31) using manual turning movement counts that included conflicting pedestrians and vehicle classifications. These counts were conducted on weekdays from 6:00 to 9:00 AM, from 3:00 to 6:00 PM, and from 12:00 to 4:00 PM on Saturday. Raw turning movement count data is provided in Appendix 2.2.

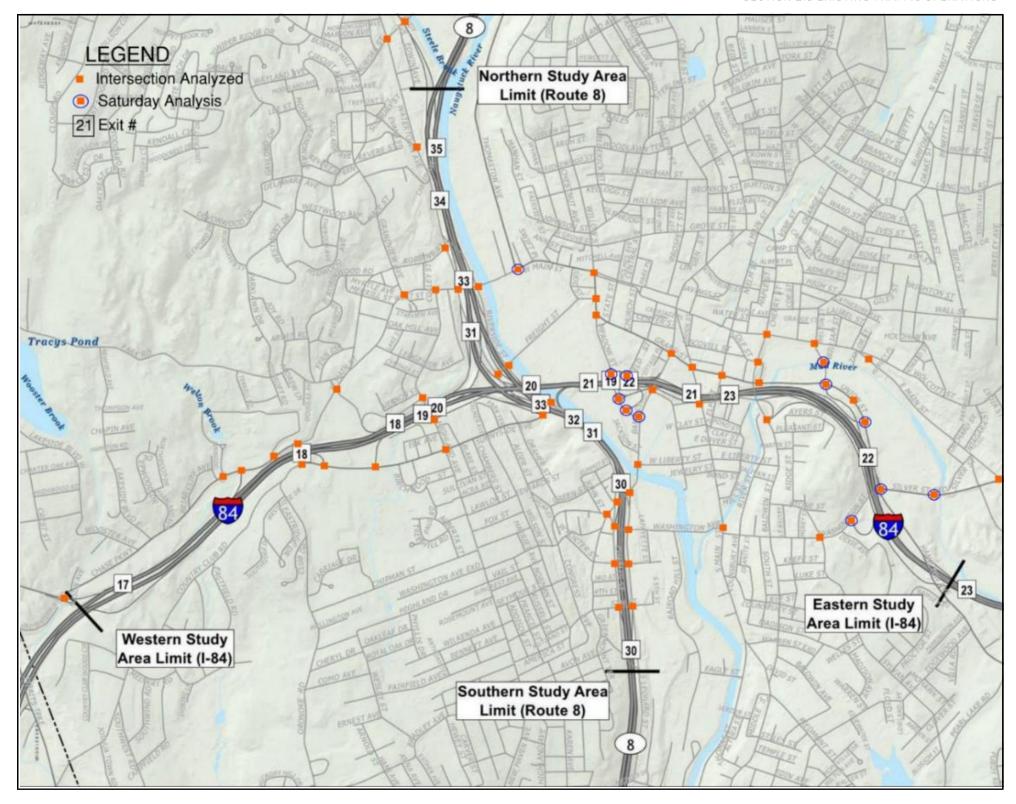
Figure 2-31 Analyzed Arterials and Intersections Map

A total of 65 intersections were analyzed in the AM and PM peak hours. A limited Saturday mid-day (SAT) analysis was performed on 12 intersections around the Brass Mill Center Shopping Mall and at the intersection of West Main Street and Thomaston Avenue. The peak traffic conditions identified for analysis were determined to be 7:30 AM – 8:30 AM, 4:30 – 5:30 PM, and 12:00 PM – 1:00 PM, for the AM, PM and SAT peak hours, respectively. A map of the intersections analyzed is shown in **Figure 2-31** (a detailed map of analysis locations can be found in **Appendix 2.3** (refer to **Intersection Analysis Location Figures**). The intersections with state-owned traffic signals that were studied include:

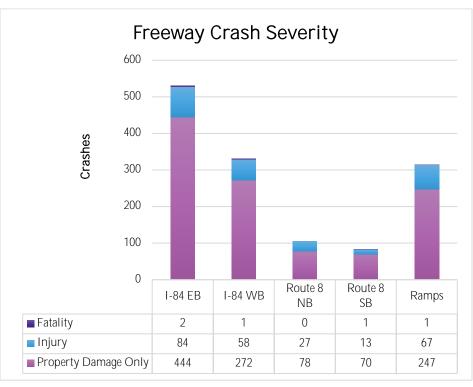
Figure 2-51 Freeway Crash Severity

A summary of mainline crash statistics by severity is provided in the following figure.

The overall proportion of rear-end crashes (46 percent) seems consistent with observed congested flow conditions where vehicles may need to stop suddenly. Specifically, approximately 60% of I-84 eastbound crashes were rear-end type which corresponds to the higher vehicle density and worse capacity performance observed for eastbound I-84 noted in Section 2.3 Existing Traffic Operations.

Similarly, the fixed object crashes that involved no secondary vehicle highlight potential geometric and/or speeding concerns. Fixed object crashes represented a large portion of crashes (45 percent) along Route 8 which can be primarily attributed to existing shoulder widths and compound curve features that do not meet current design standards.

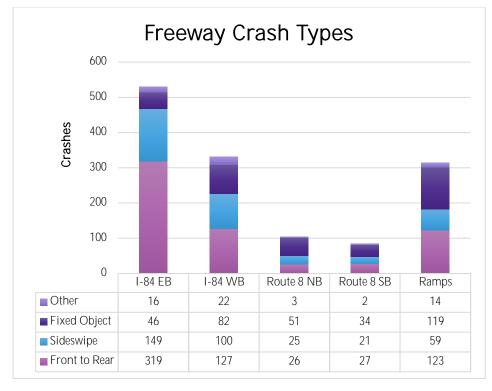
Figure 2-52 Crash Type

A summary of mainline crash statistics by type is provided in the following figure.

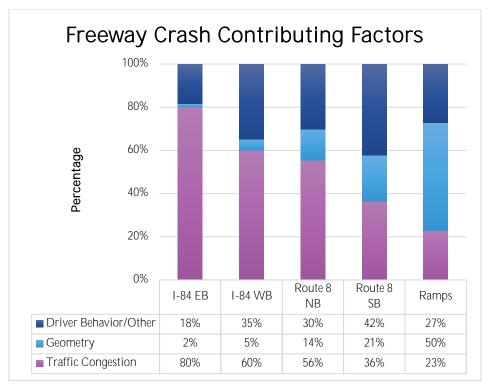
Figure 2-55 Freeway Crash Contributing Factors

A summary of mainline crash statistics by contributing factors is provided in the following figure.

- 1. The primary contributing factors to crashes on I-84 Eastbound were road geometry (1.57%), traffic congestion (80.11%), and driver behavior and other factors (18.32%). Congestion was generally attributed to the steep grades at the Mixmaster's approach and queuing conditions after the interchange. Geometry and driving behavior related crashes were observed more frequently near the core of the Mixmaster interchange where service ramps become closely spaced.

- 3. The primary contributing factors to crashes on Route 8 southbound were congestion (55.55%), geometry (14.29%) and driver behavior (30.16%). Geometry and driver behavior influenced crashes were generally explained by observed merging and diverging traffic, lane drops, and weaving conditions.

- 4. The primary contributing factors to crashes on Route 8 northbound were congestion (36.47%), geometry (21.18%) and driver behavior (42.35%). Geometry and driver behavior influenced crashes can be attributed to merging and diverging traffic, lane drops, and weaving conditions at higher speeds.

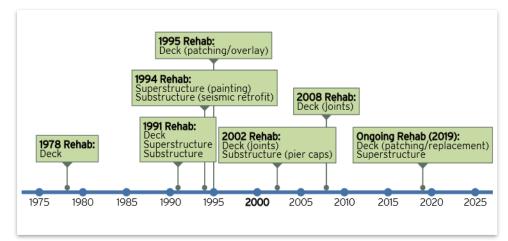
Figure 2-57 Previous Bridge Rehabilitation Projects

Note, the results of these evaluations must be understood within the context that this is only a snapshot in time. The original Mixmaster was constructed and opened to traffic in 1968. Since then, at least seven rehabilitation projects have been administered to improve and maintain bridge structural conditions in the Project Study Corridor (see Figure 2-57) At least 10 of the 62 bridges studied has planned rehabilitation work in an ongoing or programmed project (see Table 2-46). Weighted by deck area, more than 60 percent of these bridges are scheduled for rehabilitation. Furthermore, after a bridge's initial rehabilitation, regular rehabilitation projects are typically required every 20 to 25 years. How rehabilitation projects were accounted for when forecasting future structural conditions is explained further under Section 3.5 Future Structural Conditions.

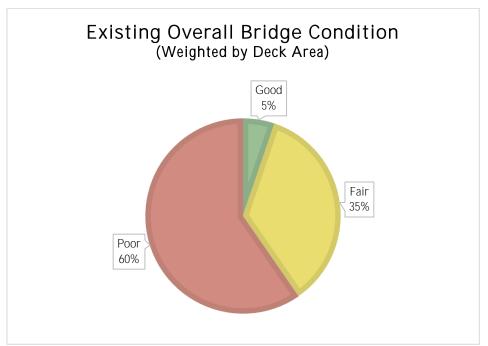
Figure 2-59 Existing Overall Bridge Condition

The existing physical conditions of bridges in the project study area were investigated by reviewing current CTDOT bridge inspection reports. Most of these bridges are in overall poor condition and structurally deficient; about 60 percent when weighted by total deck area (see Figure 2-59). By this same measure they account for around 17 percent of all structurally deficient bridges in the State's National Highway System (NHS) NBI bridge inventory:

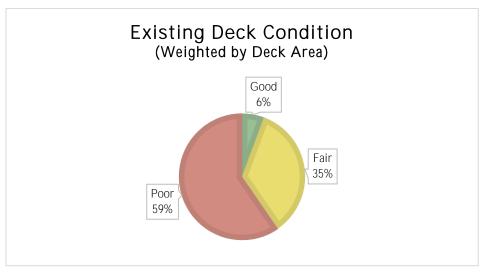
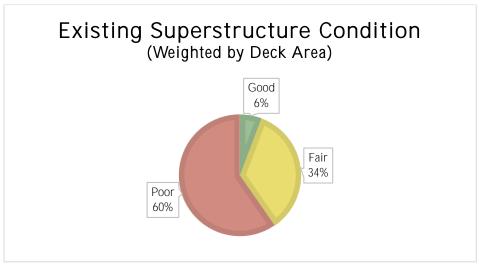
Figure 2-60 Existing Major Bridge Component Conditions

Existing physical conditions of the studied bridges are also summarized by major components in **Figure 2-60**.

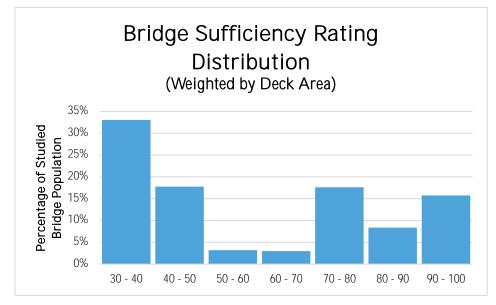
Figure 2-63 Bridge Sufficiency Rating Distribution

The sufficiency ratings of the studied bridges were summarized from current CTDOT bridge inspection reports and weighted by deck area (see **Figure 2-63** below). More than 50 percent of the studied bridges have a sufficiency rating of less than 50.

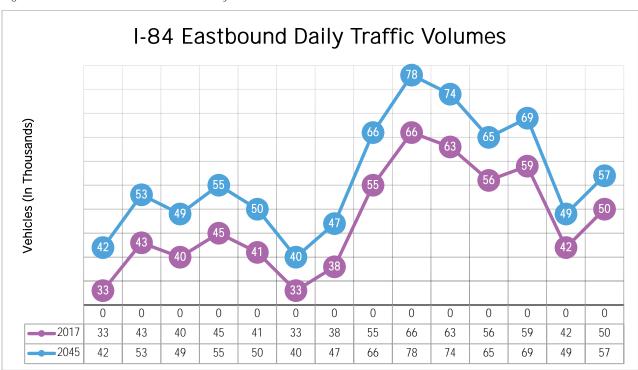
Figure 3-1 I-84 Eastbound 2017 vs 2045 Daily Traffic Volumes

Figure 3-1 through **Figure 3-4** provide a comparison between existing (2017) and future (2045) "no build" traffic volumes for the freeway mainlines.

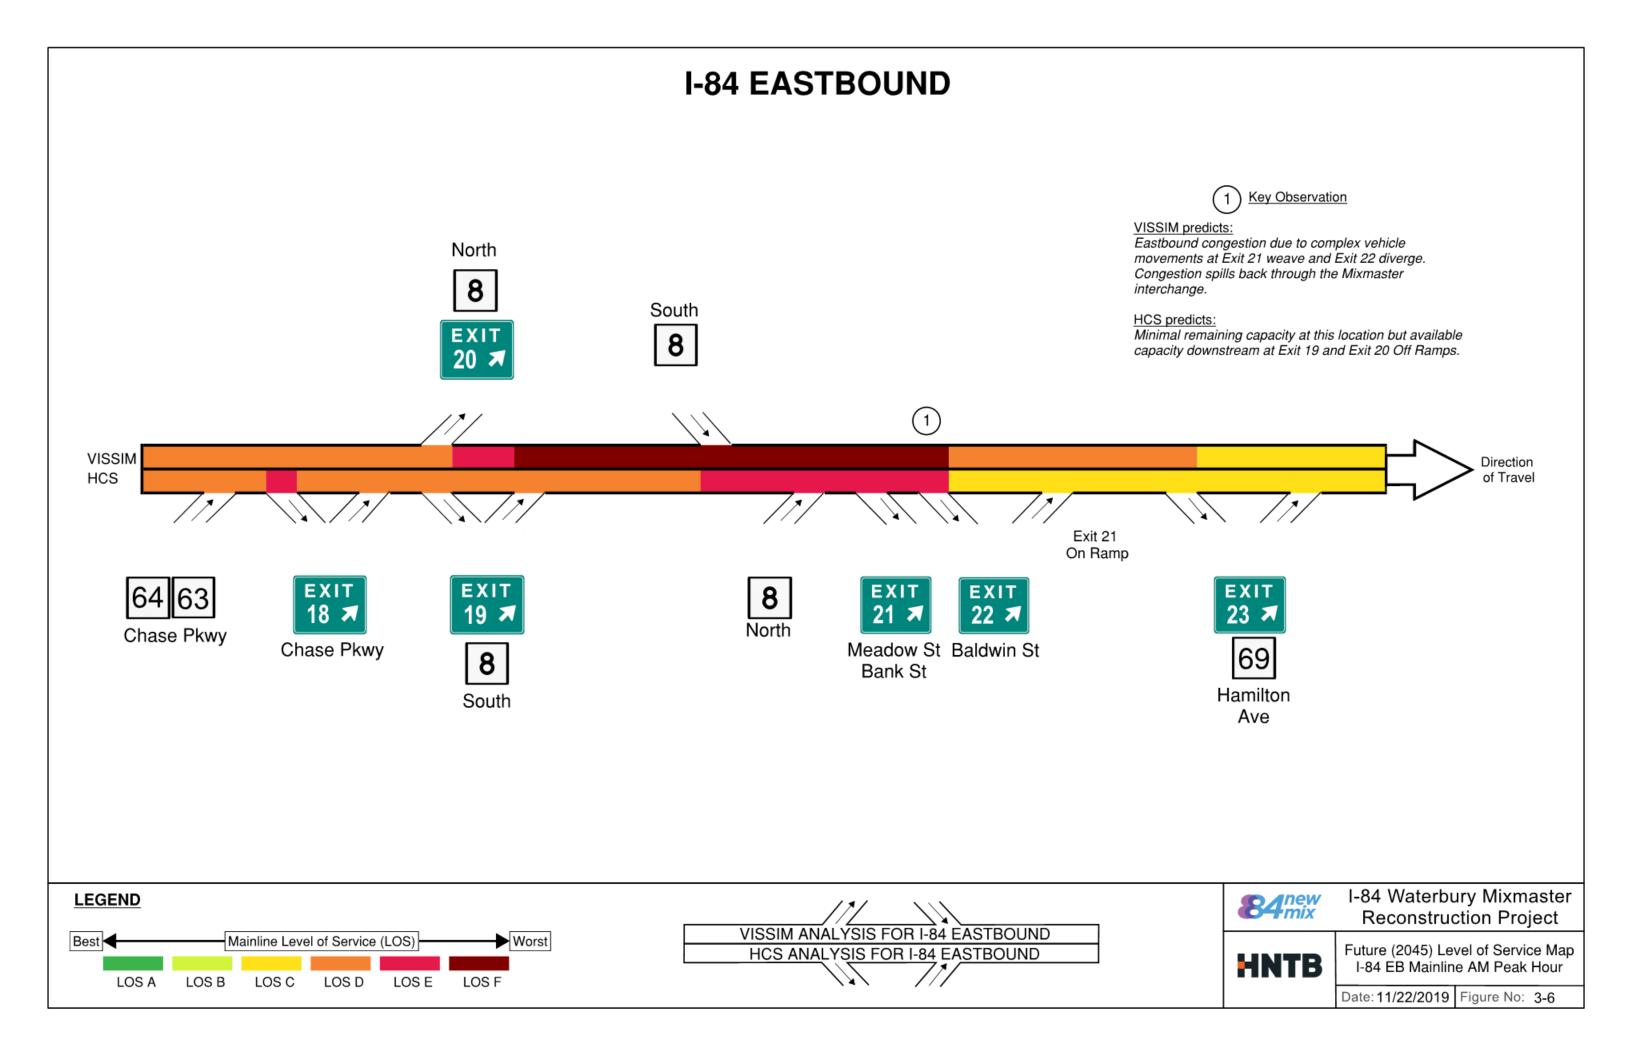
I-84 WESTBOUND Middlebury North Watertown Meadow St West Main St 8 Bank St Union St Highland Ave St South **EXIT EXIT** 8 Direction of Travel HCS VISSIM Bank St **EXIT** 8 Key Observation Key Observation South HCS predicts: Deficient LOS at Exit 22 merge area. **HCS predicts:** Deficient LOS at Route 8 and Exit 18 weave area. Deficient LOS at Exit 18 merge and Exit 17 diverge. VISSIM predicts: Less downstream vehicle density allows for slightly VISSIM predicts: better merge operation at Exit 22. Less downstream vehicle density allows for better merging and weaving operations at these locations. I-84 Waterbury Mixmaster 84mix **LEGEND** Reconstruction Project HCS ANALYSIS FOR I-84 WESTBOUND Best -Mainline Level of Service (LOS) Worst Future (2045) Level of Service Map VISSIM ANALYSIS FOR I-84 WESTBOUND **HNTB** I-84 WB Mainline AM Peak Hour LOS A LOS B LOS C LOS D LOS E LOS F Date: 11/22/2019 Figure No: 3-8

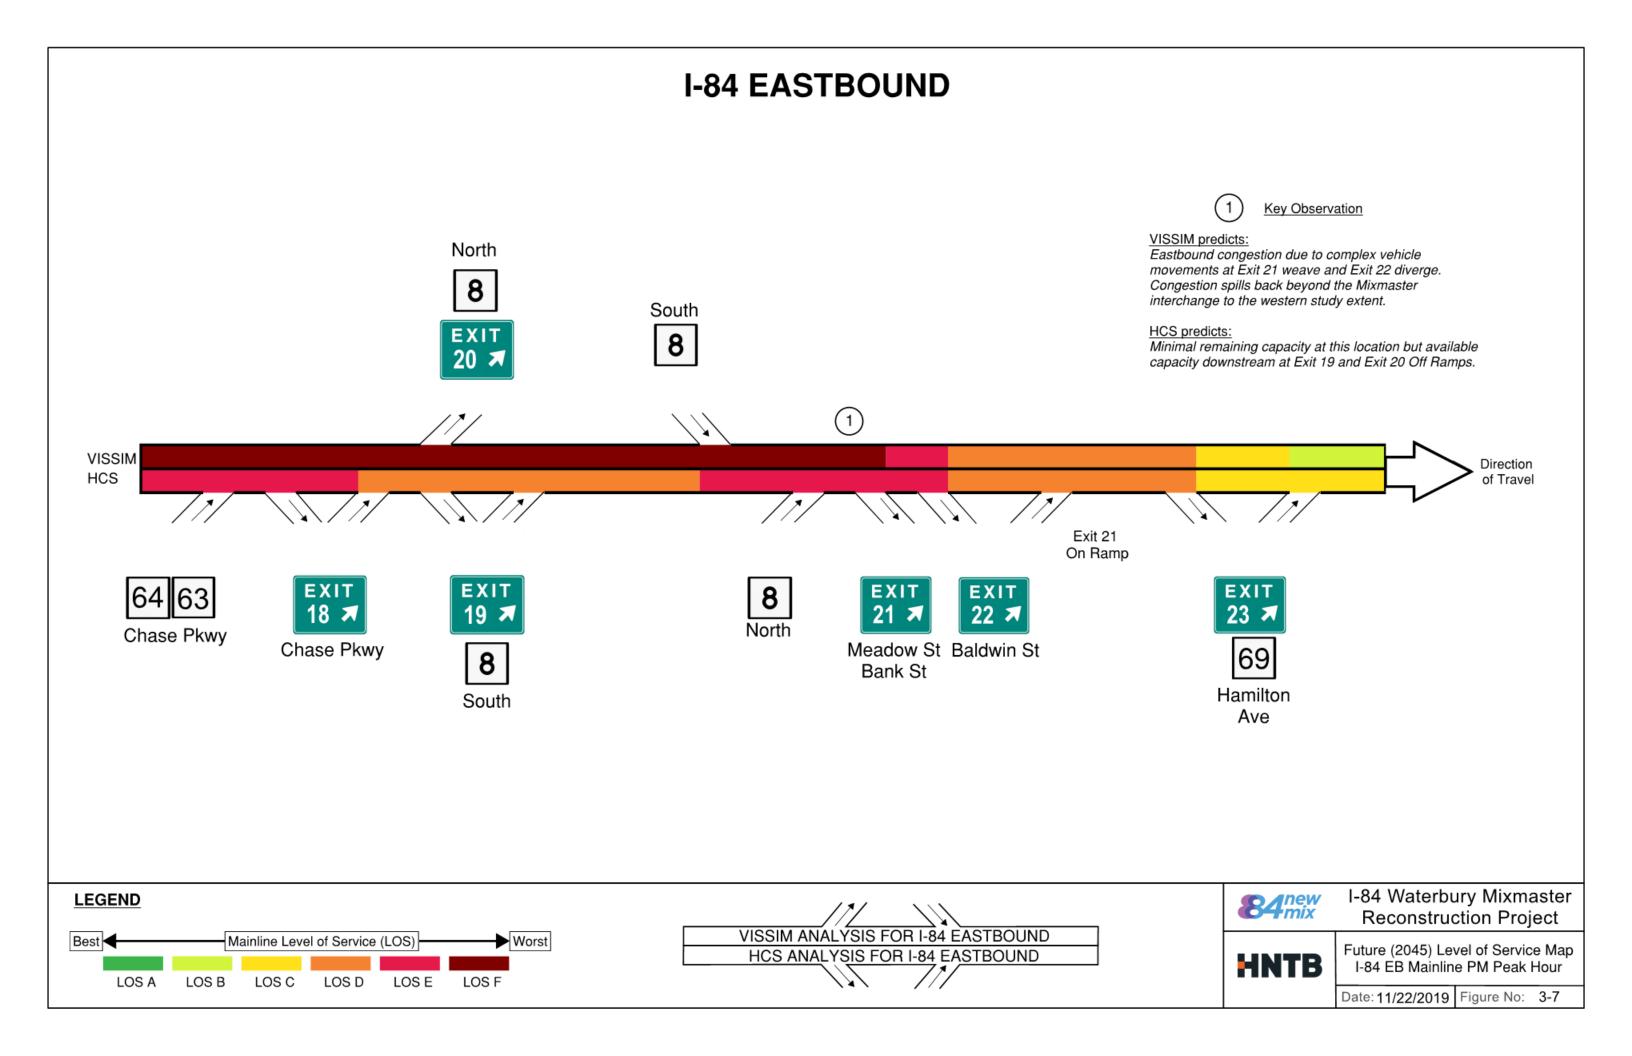
I-84 WESTBOUND Middlebury North Watertown Meadow St West Main St 8 Bank St Union St Highland Ave St South **EXIT EXIT EXIT** 8 Direction of Travel HCS VISSIM Bank St **EXIT** 8 Key Observation **Key Observation** South HCS predicts: **HCS predicts:** Deficient LOS at Exit 20 diverge. LOS D at Route 8 and Exit 18 weave area. Deficient LOS at Exit 22 merge area and the freeway Deficient LOS at Exit 18 merge and Exit 17 diverge. segment between Exit 21 merge and diverge areas. VISSIM predicts: VISSIM predicts: Less downstream vehicle density at the Route 8 SB Congestion at Exit 20 diverge spills back through Exit 19 merge area allows for better merging and weaving diverge area, worsening traffic operations downstream operations at these locations. The lower through Exit 21 and 22. downstream density is caused by the traffic metering due to congestion at Exit 20, 21, and 22. I-84 Waterbury Mixmaster 84mew mix **LEGEND** Reconstruction Project HCS ANALYSIS FOR I-84 WESTBOUND Best -Worst Mainline Level of Service (LOS) Future (2045) Level of Service Map VISSIM ANALYSIS FOR I-84 WESTBOUND HNTB I-84 WB Mainline PM Peak Hour LOS B LOS D LOS F LOS A LOS C LOS E Date: 11/22/2019 Figure No: 3-9

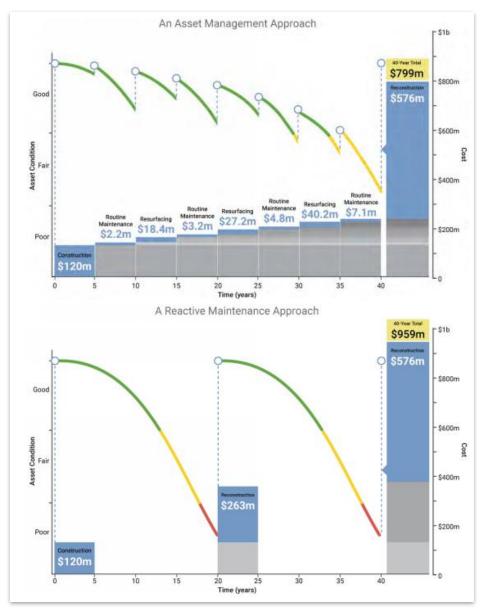
Figure 3-19 Proactive Maintenance vs. Reactive Maintenance ⁵

Predicting post-rehabilitation physical condition was a major consideration in these forecasts. The CTDOT administers preventative rehabilitation projects to maintain the condition of state-owned bridges. Rather than restoring a bridge to "like-new" condition in reaction to severe deterioration, this method of asset management uses relatively minor rehabilitation projects to keep each bridge in a "state of good repair" throughout its life. Appreciable savings can be realized over a bridge's life by using this proactive approach to asset management (see Figure 3-19). However, a natural trend resulting from this approach is the increased frequency of preservation/rehabilitation projects performed as the bridge ages. Another observed trend is that rehabilitation projects performed later in the asset's life tend to be more substantial and are generally less effective.

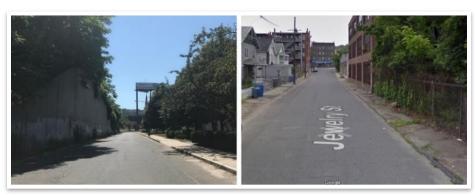
Figure 4-25 Photos of Market Square (Left) and Jewelry Street (Right)

- Most of the neighborhoods have continuous sidewalks along the main roads, but they are not particularly well maintained, especially those that pass by vacant or semi-used lots.
- On side streets, there are either sidewalks on one side of the road or sidewalks without curbs.
- Most sidewalks are on uneven ground and are generally narrow.
- There is a lack of street trees and pedestrian friendly amenities such as pedestrian lights, benches, or trash receptacles.
- Sidewalks along the big box retail parcels and parallel to I-84 have harsh conditions with narrow, exposed sidewalks, and no building frontage.

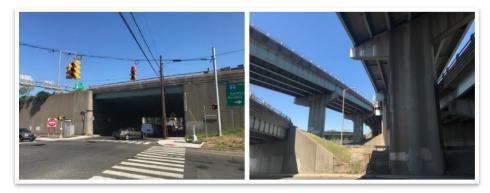
Figure 4-27 Photos of South Main Street (Left) and Bank Street (Right) Underpasses

- Conditions are generally unwelcoming.
- The large overhead interchange creates a dark and overwhelming environment for pedestrians.
- Sidewalks are not present on both sides of the road and most existing sidewalks are very narrow, with no buffer from vehicular traffic.
- There is a lack of lighting underneath the interchange, creating safety concerns at night or during unfavorable weather.

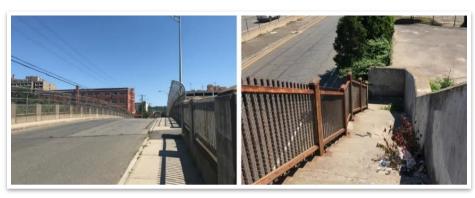
Figure 4-29 Photos of South Elm Street Overpass (Left) and McMahon Street Access (Right)

Furthermore, although there is stairway access from the South Elm Street overpass to McMahon Street below, the stairway is poorly maintained and littered with trash (see Figure 4-29). This is a notable issue because South Elm Street overpass serves as a major gateway from South End to downtown and St. Mary's Hospital. Overall, these conditions create an unwelcoming environment for walking or bicycling in addition to potential safety issues.
